**CARRIG**  
 BUILDING FABRIC CONSULTANTS

Project No: 111  
 Client: Butler Gallery  
 Drawing Title: Recommendation Drawings  
 Drawing No: North Elevation (North Wing)

Project: Butler Gallery

Condition Drawing

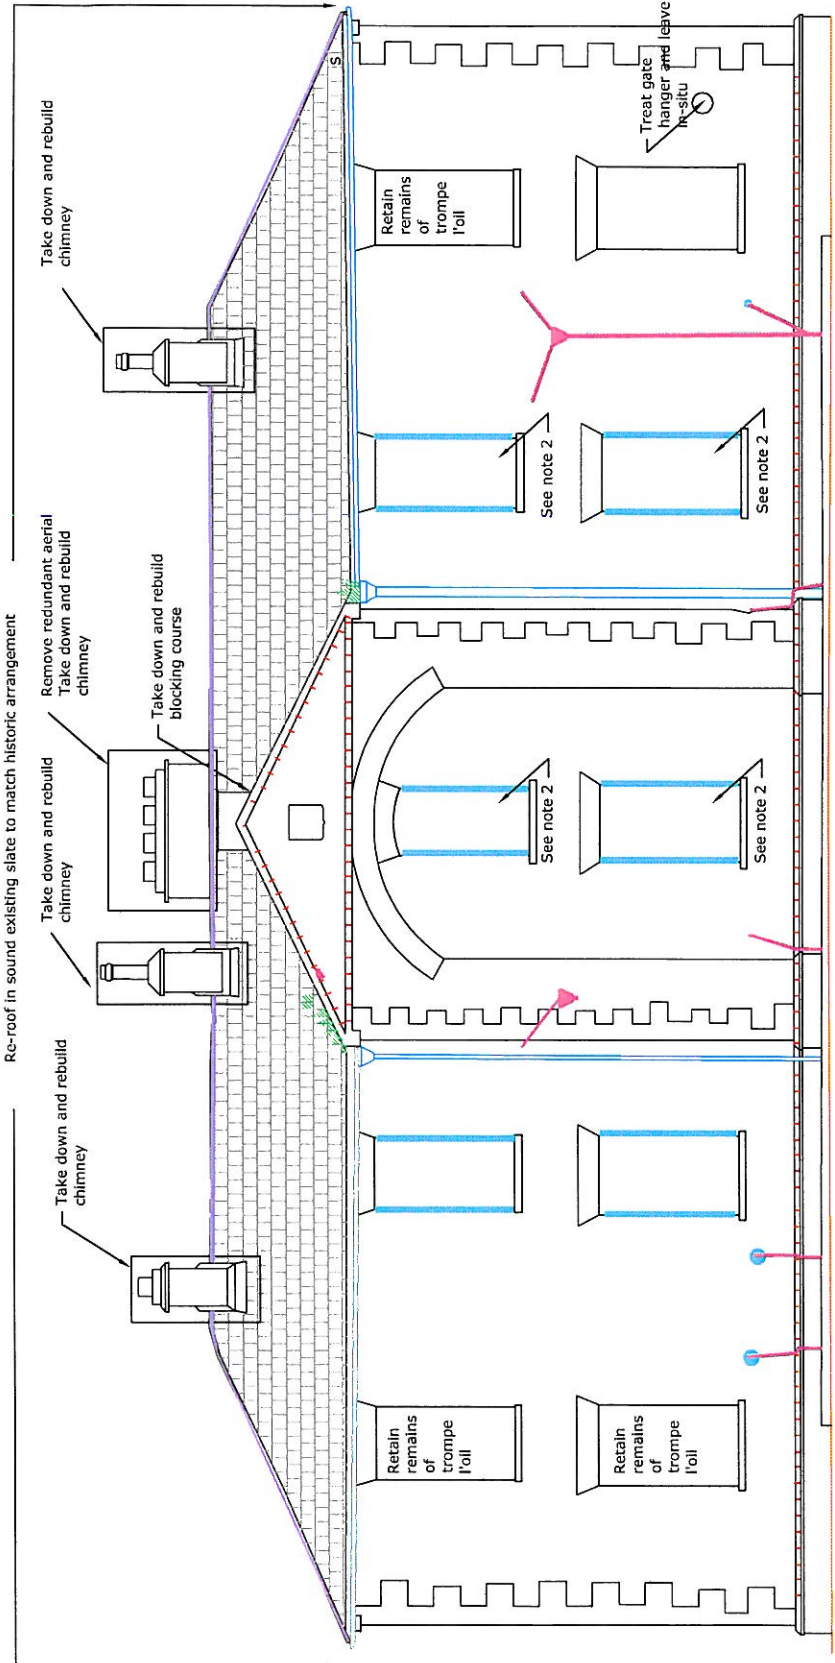
**NORTH ELEVATION (North Wing)**

Engineer to investigate

Biocide and remove
-

Remove cementitious render and replace with lime harling
-

Replace failed lead roll with new lead to match historic detail
-

Mortar repair/incident stone as necessary
-

Repoint in lime mortar
-

Re - route sensitively
-

Remove insensitively installed and redundant soil/waste pipes

Remove cement drain  
 Install French drain

Re-harl elevation in lime based material to match existing

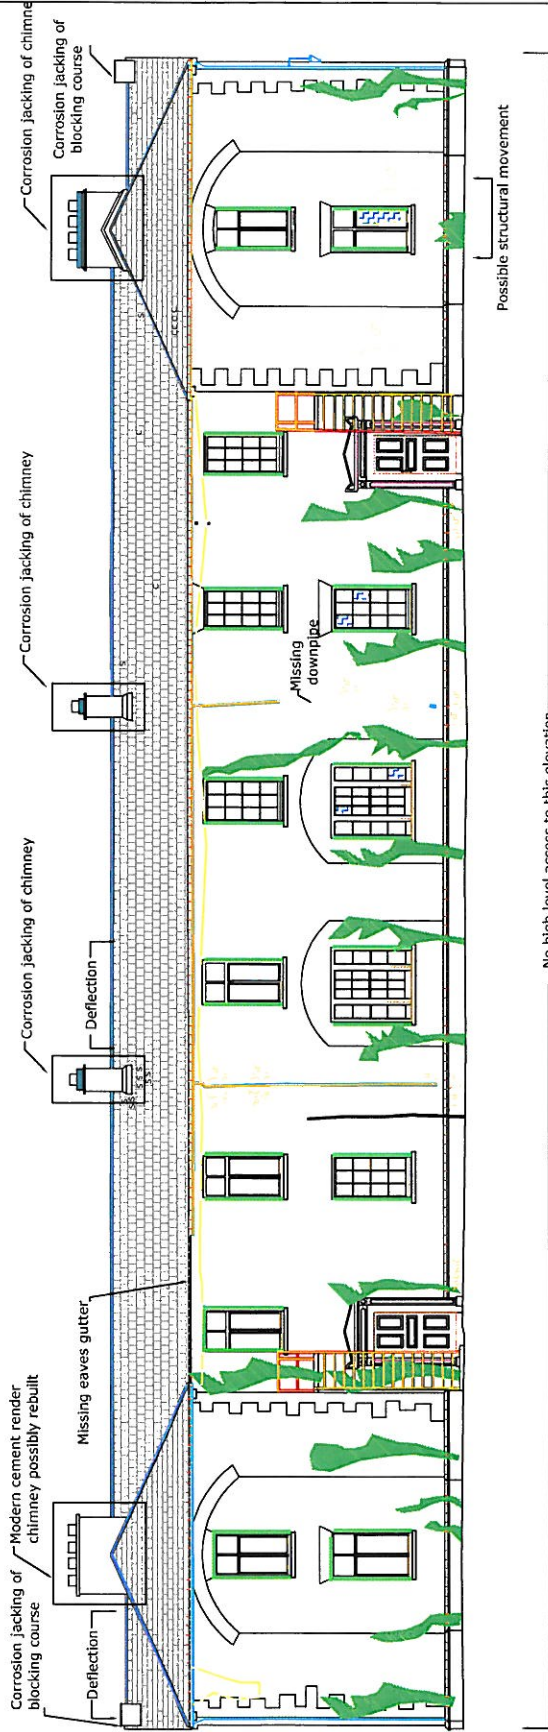
EAST ELEVATION

Biological growth
-

Corroded rainwater goods
-

Cracked slate
-

Cracked/missing glazing
-

Cementitious render
-

Failed lead roll
-

Fractured/cracked masonry
-

Failed flashing
-

Fractured weathered stone
-

Open joints
-

Poorly routed cable
-

Timber decay
-

Tingle repair
-

Slipped slate
-

UPVC rainwater goods/soil pipes

Note: Remnants of lime harling to this elevation

No high level access to this elevation
