TALBOT'S TOWER

Kilkenny

Conservation Report Completion of 2010 Works

November 2010

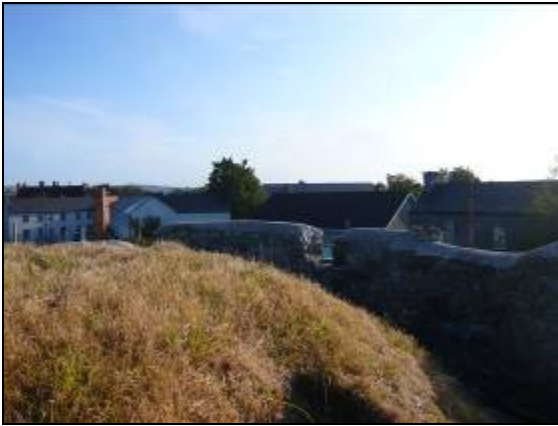
Figure 1

The roof covered by an earthen mound. This is thought to have been from the Victorian era, when a roof garden was established. It was decided to remove this mound as it was causing a major problem with water ingress into the tower below.

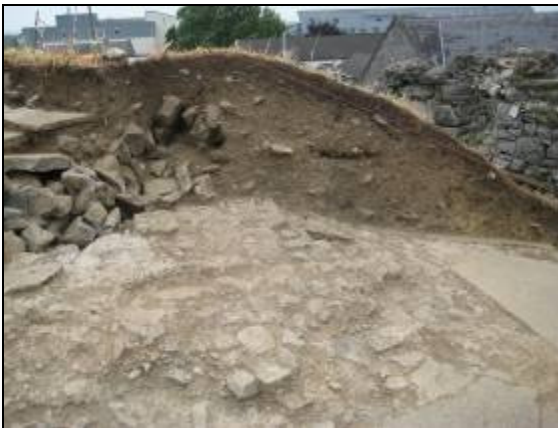
Figure 2

The roof was originally clad in flagstones. Excavations revealed that less than one quarter of the flagstones remained in-situ. A large hole in the centre of the roof was a cause of serious water ingress into the tower below. A detailed survey of the roof was carried out by the building archaeologist.

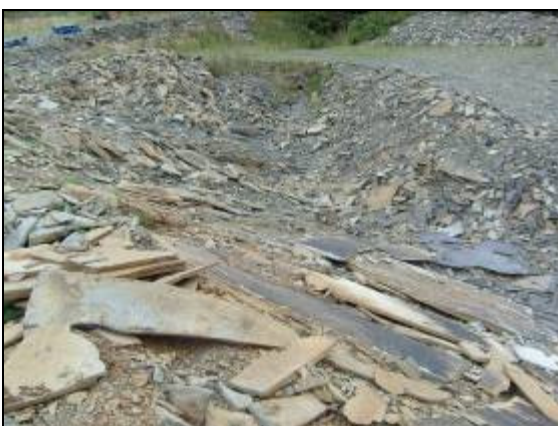
Figure 3

A suitable flagstone was sourced locally in Kilenale quarry in Co. Tipperary. This was assessed by our in house geologist and deemed to be a suitable match.

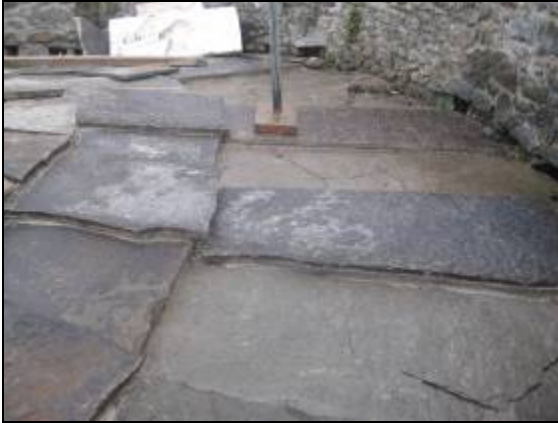
Figure 4

The roof had a series of saddle stones that directed water to the perimeter chutes. It also had three steps, creating a fall to the perimeter. Existing flagstones remained in-situ and new stones were set on a lime base, with existing steps maintained.

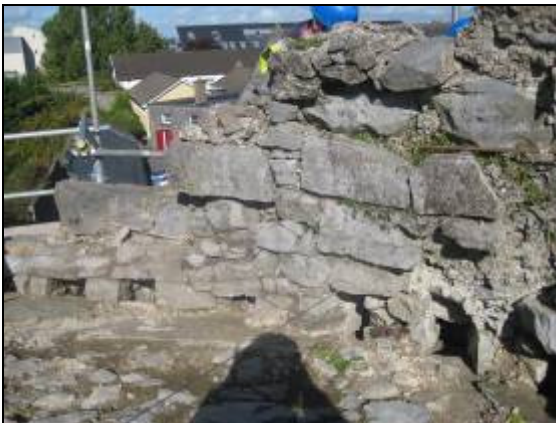
Figure 5

The parapet from chute 30 to 42 was unstable, with one section having collapsed into the roof. This section was taken down and rebuilt. A stone accurate survey was carried out before the section of wall was taken down.

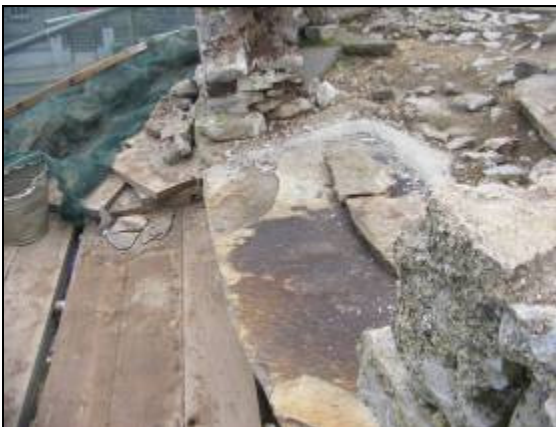
Figure 6

Here the parapet wall was taken down, New flagstones were inserted and the chutes were rebuilt.

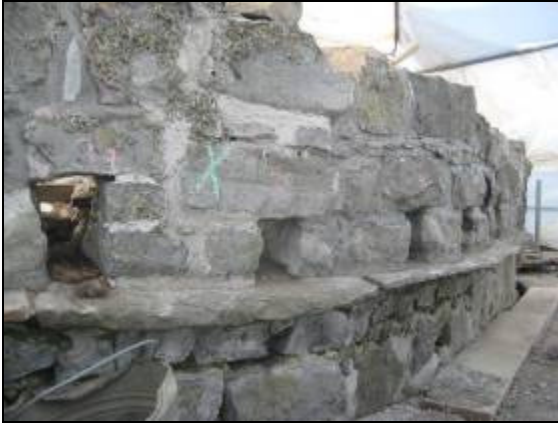
Figure 7

This is a view of the external parapet wall, showing the rebuilt section and new flagstone chute.

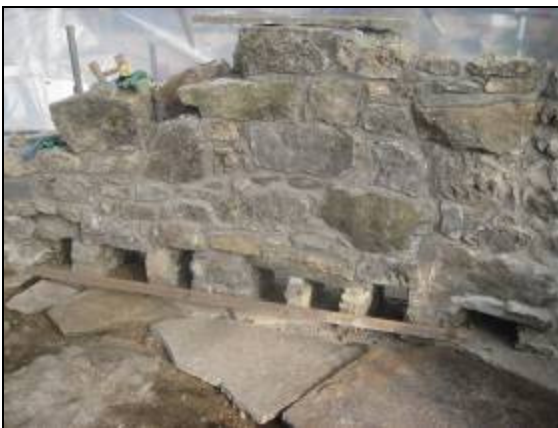
Figure 8

This is a view of the internal parapet wall, showing the rebuilding underway. Some flagstone chutes were extant and these were kept in-situ untouched.

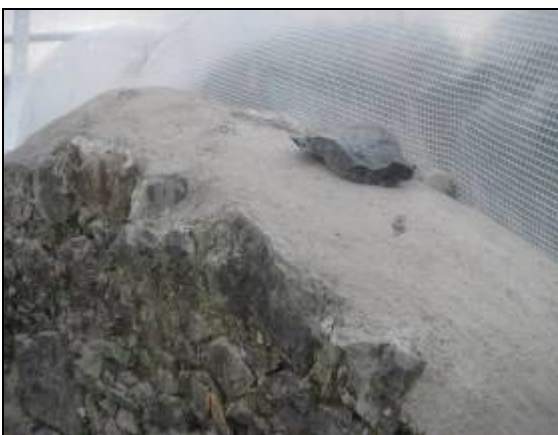
Figure 9

The parapet wall was capped to prevent water penetrating into the wall, causing further deterioration to the wall. Some of the capping carried out in a previous phase was damaged by the severe winter last year. Prolonged saturation, followed by a long severe period of below zero temperatures caused the lime capping to crack. This was repaired while the scaffolding was still in place.

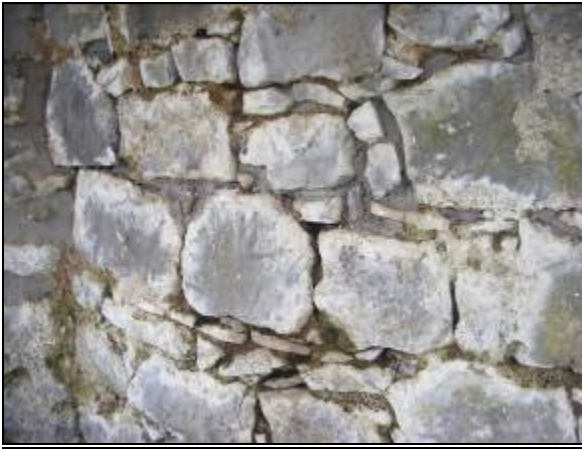
Figure 10

The wall was prepared for repointing. Here pinning stones were inserted before pointing commenced.

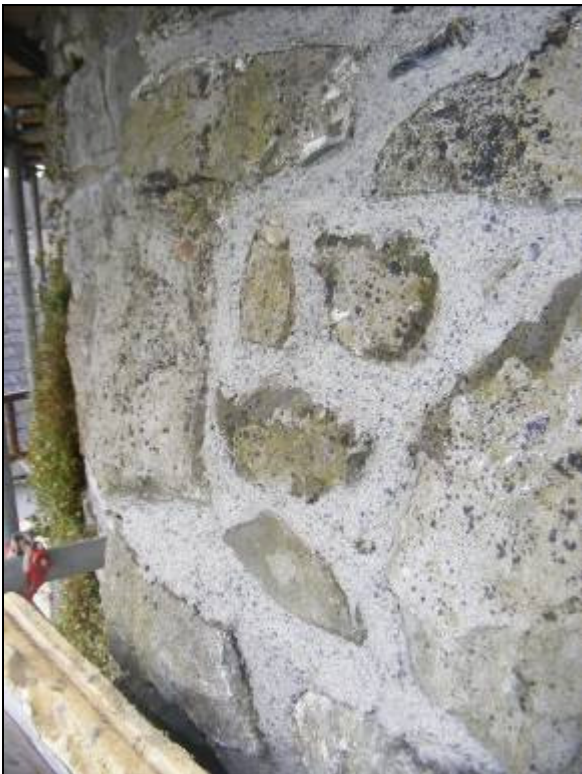
Figure 11

A sample of pointing was prepared for inspection beforehand. Two different types of mortar were used, to differentiate between the Anglo-Norman period and the later medieval period.

Specification was 1 part NHL3.5 : 2.5 sand. Sand was a mix of 8mm, 6mm and 2mm. Grey colour was achieved using limestone dust.

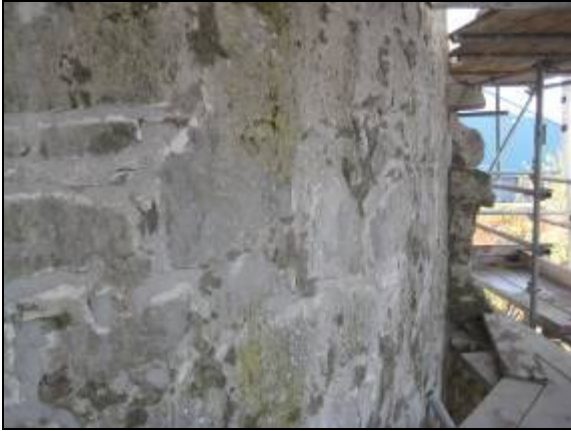
Figure 12

All original and stable mortar was retained. Repointing was only carried out to areas of the facade where mortar had washed out.

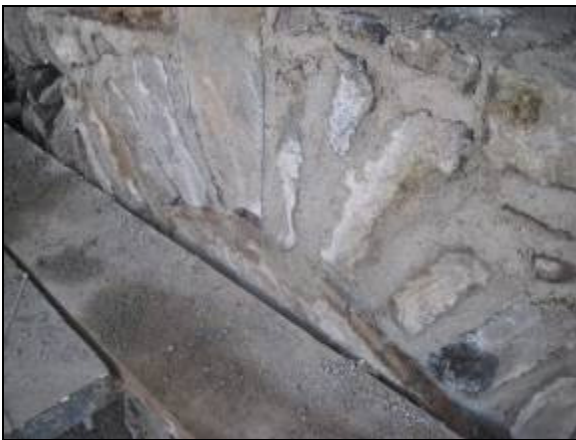
Figure 13

The external arch over the entrance door was rebuilt, having been robbed out in the past

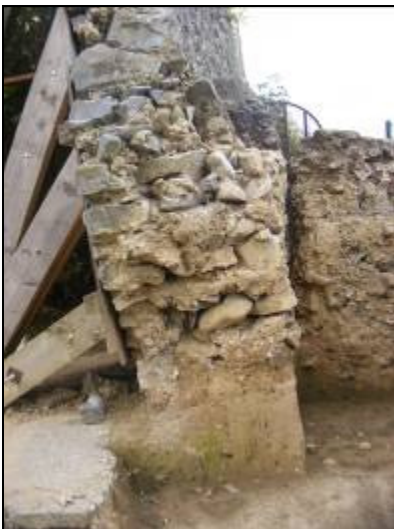
Figure 14

It was agreed to postpone this element of work until the adjacent intra mural stairs is being rebuilt. The wall has been fully recorded.
