# TALBOT'S TOWER

Kilkenny

## Final Report on Conservation Works

2011

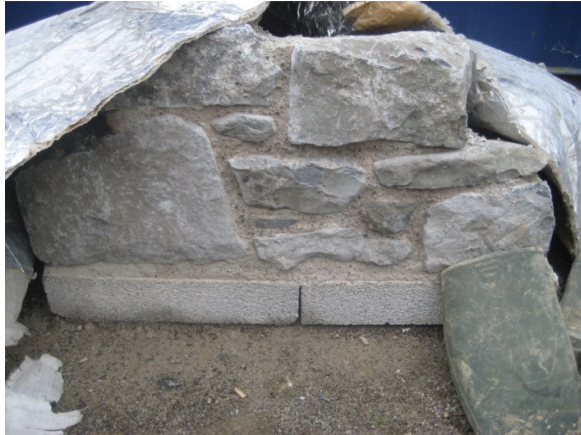
Sample of stonework and mortar approved before works commenced.

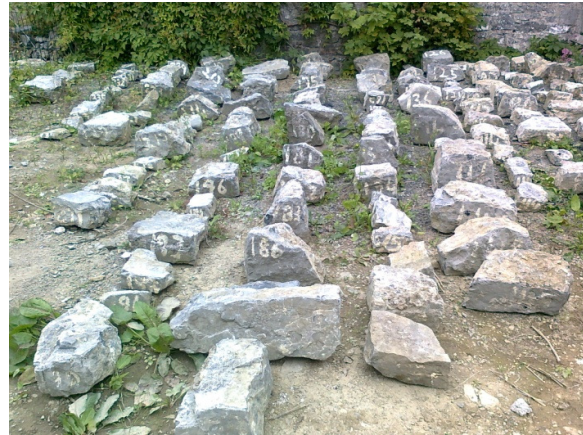
Numbered stones set out in preparation for reinstatement.

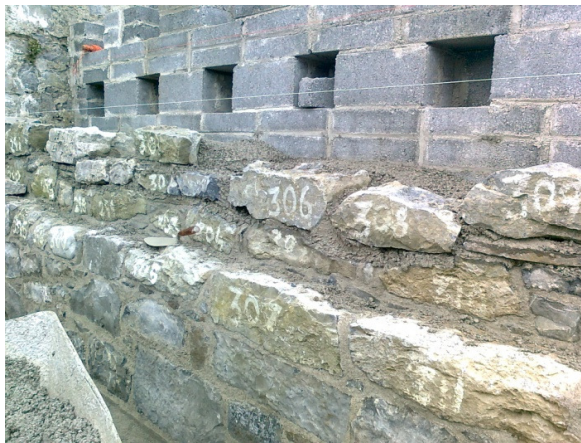
East wall under construction with numbered stones being reinstated exactly in accordance with the survey drawing, and the wall is further advanced below.

The east wall was rebuilt to exactly match existing, reusing existing numbered stone and other stone on site.

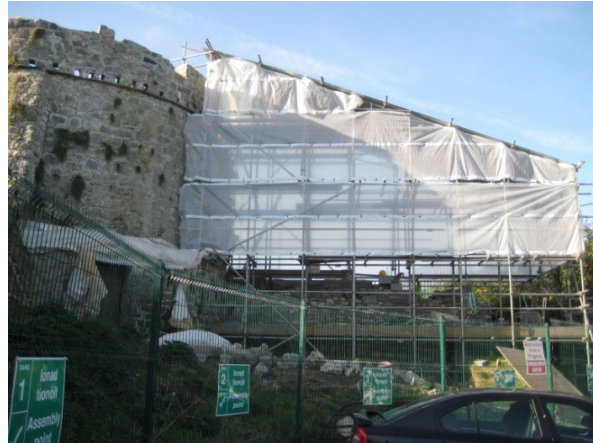
Covered scaffolding allowed for working in inclement weather and protecting the work on completion. Below two corbel stones were reinstated.

The works were well protected against the elements during the course of the project. A covered scaffold protected the newly built stonework from rain and also sheltered the new lime work. In addition, all new lime work was protected with hessian, insulation and plastic. This was removed during daylight and reinstated at night. The works will continue to be protected over the winter months.

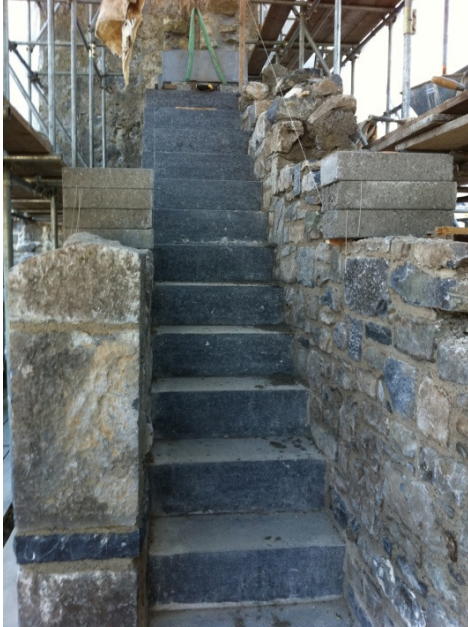
Limestone steps up to the landing level

Between these two walls a set of stone steps was built. The new limestone steps exactly match rake and size of the existing steps. A flame finish was chosen and approved prior to this element of the work commencing. A new timber gate at the bottom of the steps has been manufactured in Irish oak.

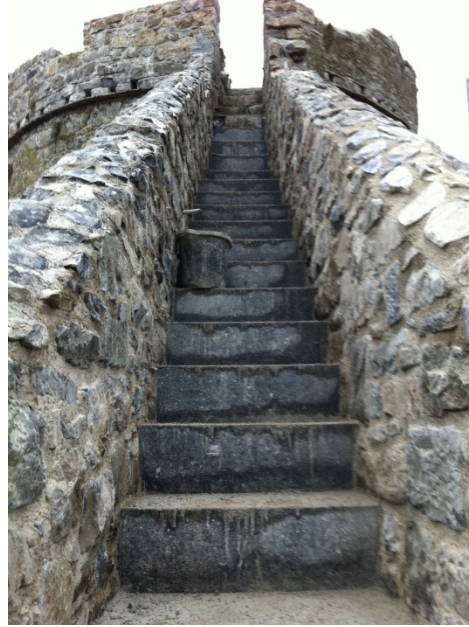
The completed steps. The new steps marry into existing steps, with a steep rake at the upper level.

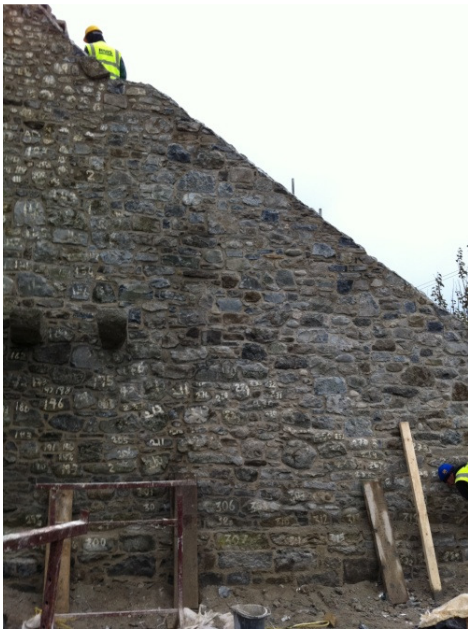
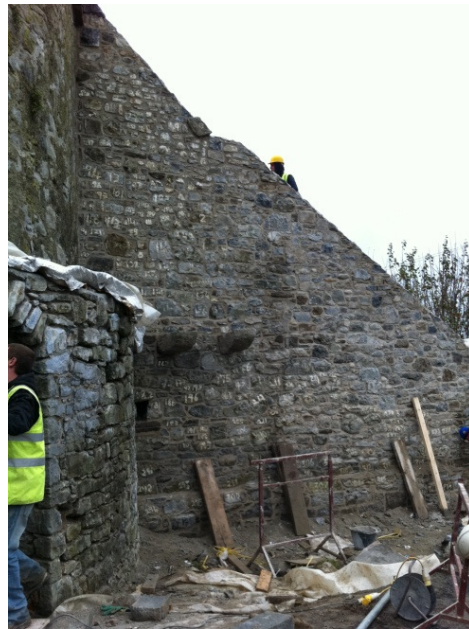
Two images of the completed east elevation

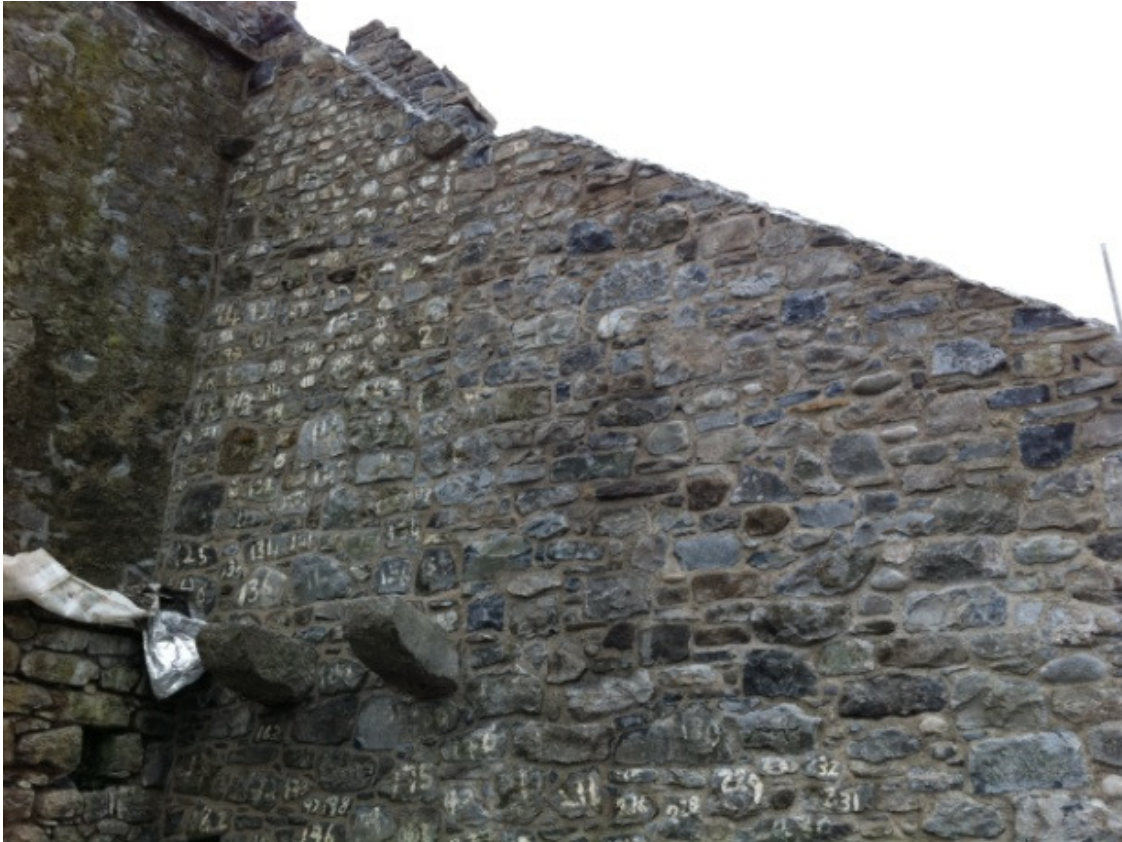
A close up of the east elevation, with corbel stones, which once may have supported a timber wall walk. The numbered stones have been rebuilt in the correct location. Compare it to the rectified photograph below dating to before the wall was taken down in 2007.

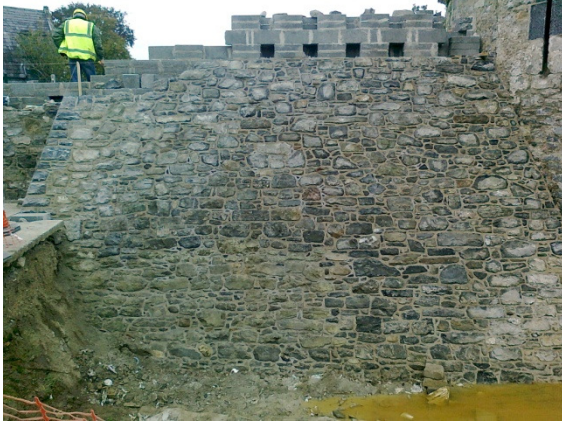
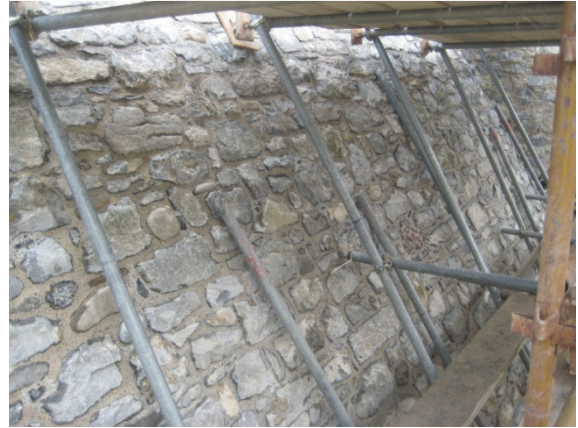
Two views of the base batter repaired and built up to its original height.

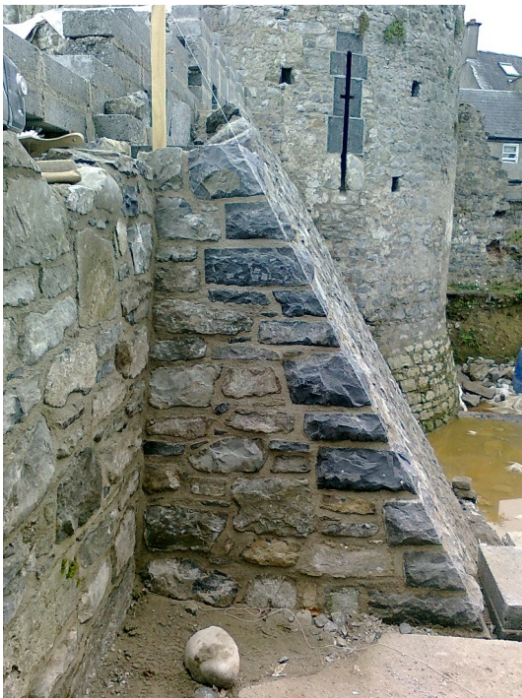
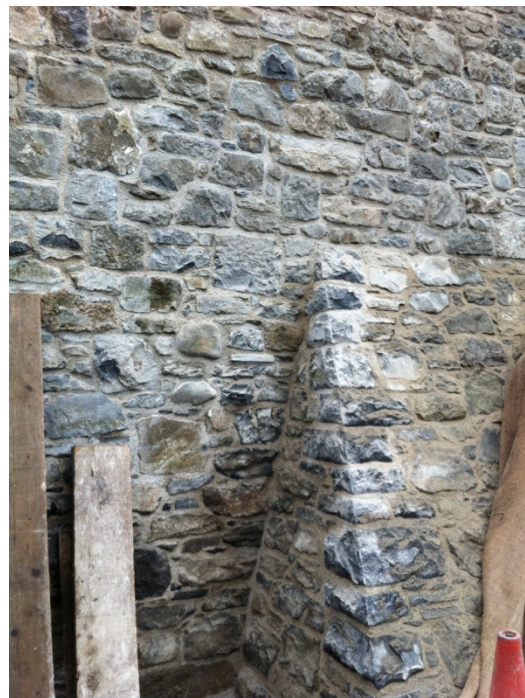
Two views of the corner of the base batter, under construction and completed

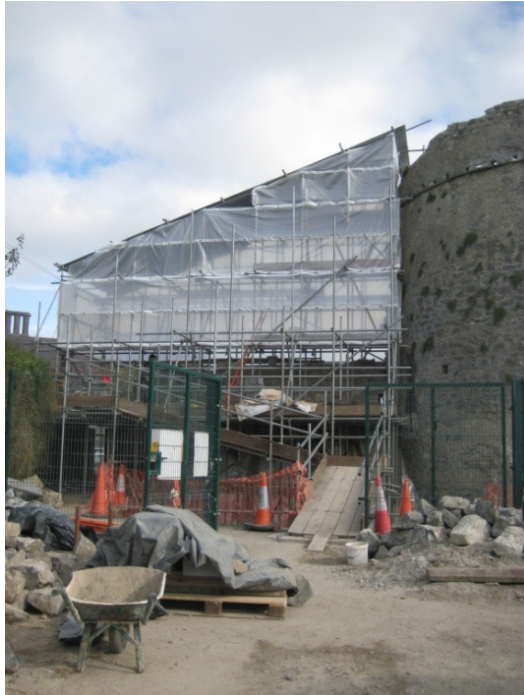
The covered scaffolding viewed from the west. The size and scale of the building allowed for a ramped access rather than the traditional method of ladder access. This was a more efficient way of carrying stone and wheelbarrows of lime mortar.

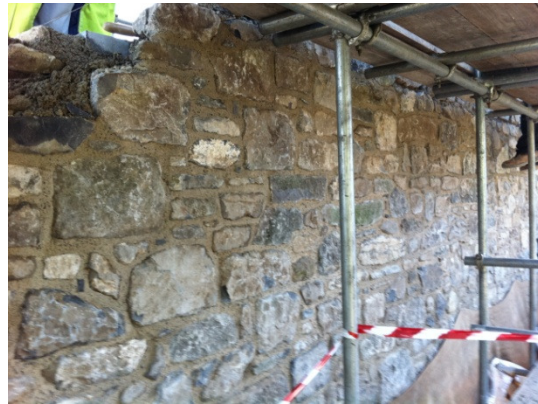
Close up of the stonework to the west wall

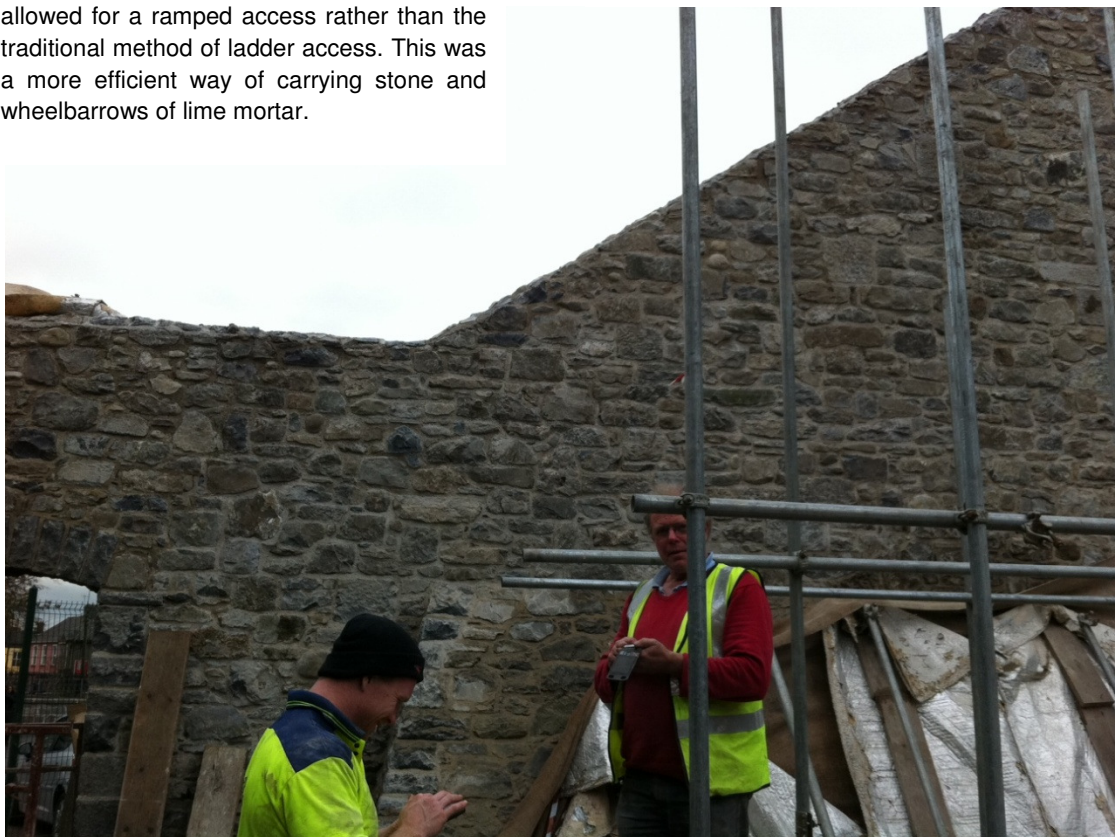
The completed west wall

The west wall was rebuilt using existing stone from site. Additional rubble limestone, salvaged from sites around the city, and stored in a council depot on the Hebron Road, was sorted through and used in addition to the stone on site.

Because the same level of survey information was not available for the west wall, it was originally proposed to finish this wall in a shelter coat of lime render, except for the small section at the top of the wall that will be left without render. However, the workmanship is very high on the finished wall and the Steering Committee decided not to proceed with the shelter coat, as the monument may read clearer without it.

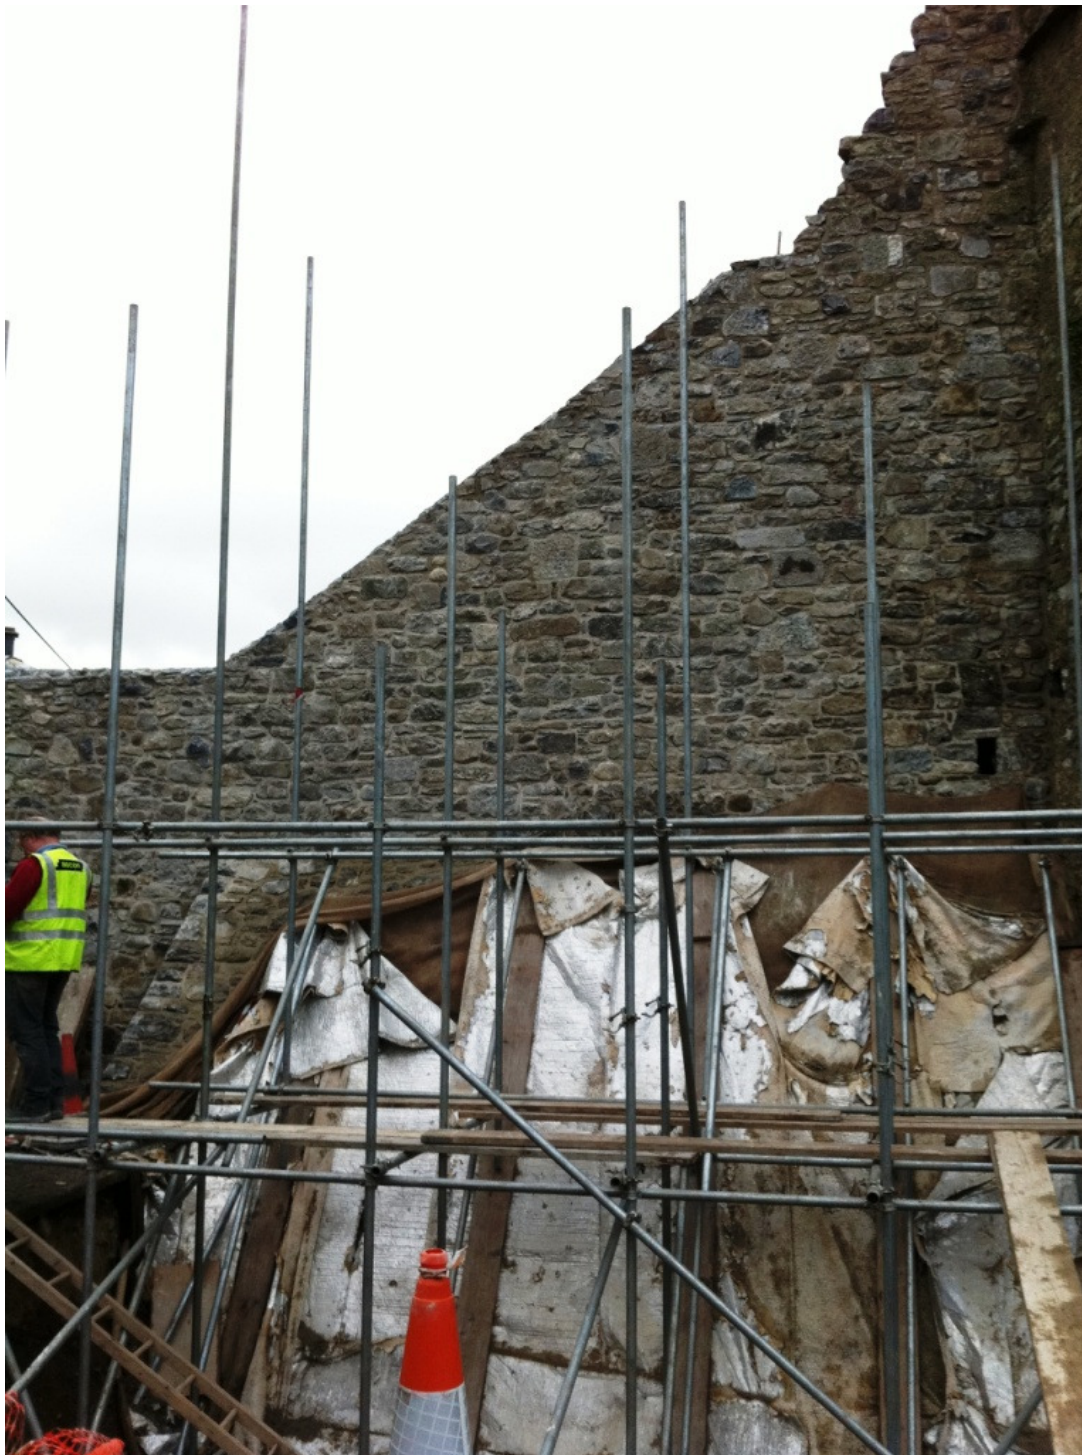
The completed west wall, with the protection still on the base batter. Note that the top section was the only extant section of the wall.

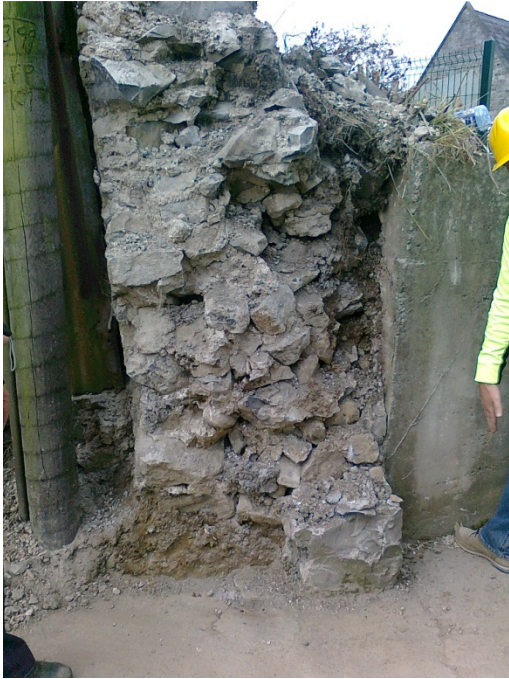
The section of north curtain wall was in imminent danger of collapse.

A small section of North Curtain Wall, rebuilt in 18<sup>th</sup> Century, was leaning heavily outwards and supported temporarily for safety. In relatively recent years an archway was created to provide access from the adjacent VEC College. The wall was recorded and taken down. A new foundation was dug. Prior to this an excavation was carried out by Kilkenny archaeology. The wall was rebuilt and a new arched opening provided.

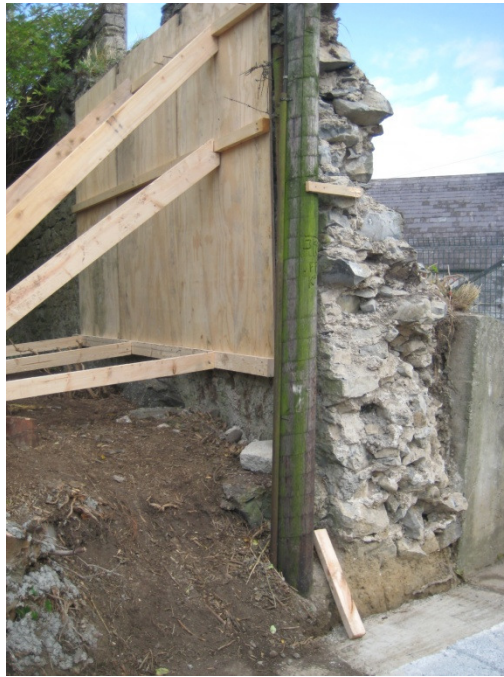
The wall was surveyed, carefully taken down. A new foundation was poured after the site was excavated by an archaeologist and the remainder of the wall has been supported with a temporary buttress.

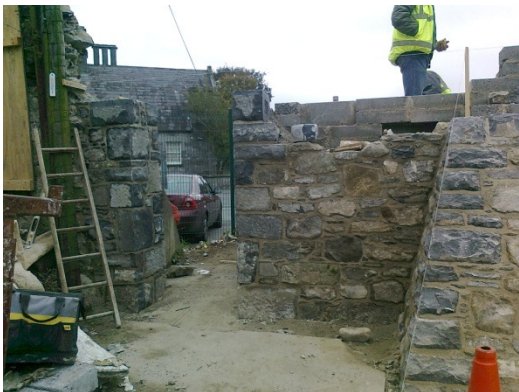
Rebuilding of section of north curtain wall under construction.

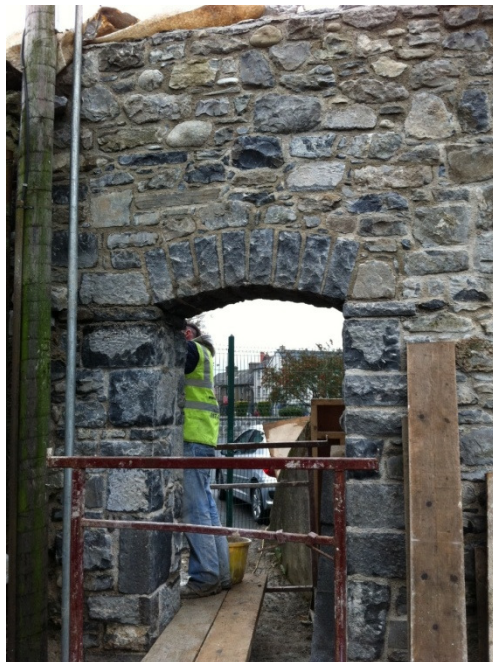
The completed section of north curtain wall, with new arch built to match the arch of the tower. The Irish oak gate has been manufactured and will be fitted when all scaffolding has been removed

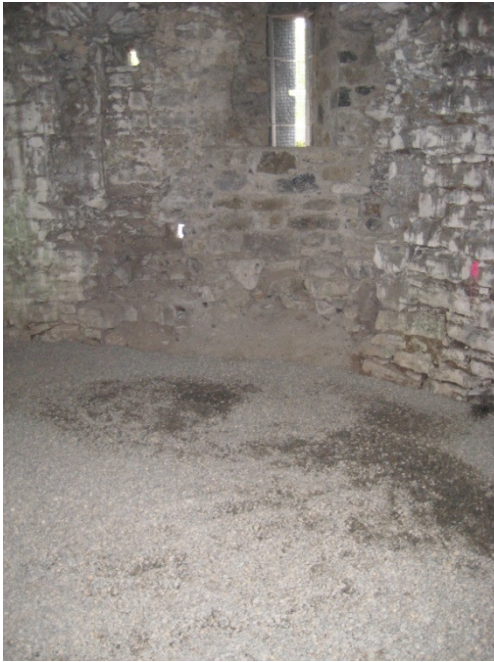
Gravel base to tower interior laid over a geotextile membrane

A gravel bed was laid over a *geotextile* membrane on the tower floor to protect the existing floor. A new Irish oak entrance door has been manufactured.

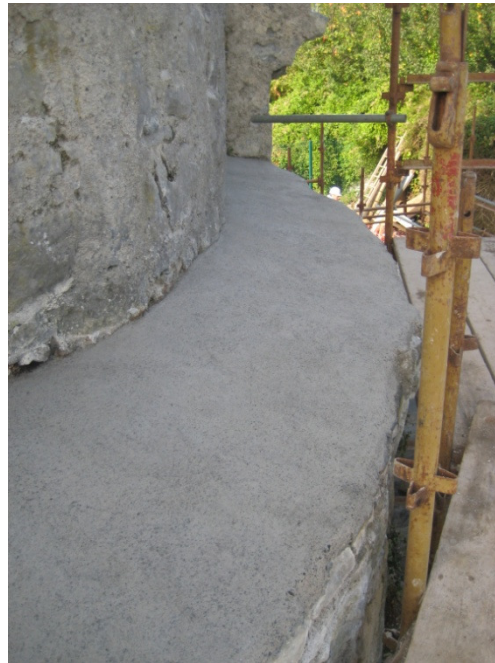
New lime capping to the wall walk
