# TALBOT'S TOWER, KILKENNY:

# EXCAVATIONS FOR THE CITY WALLS ARCHAEOLOGICAL PARK

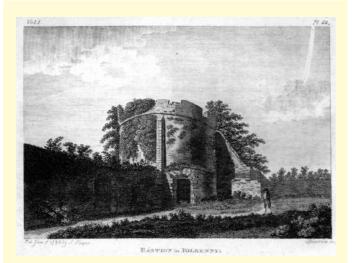
Daniel Grose's illustration of Talbot's tower which was published 1792 shows Talbot's tower from the east.

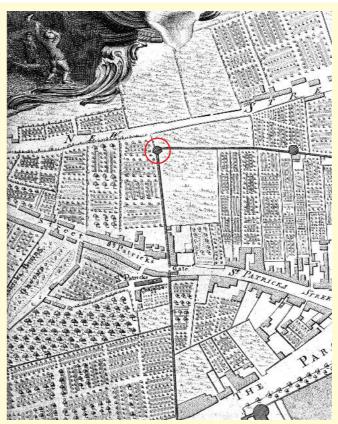
Talbot's tower marked on Rocque's map of Kilkenny 1758
