# TALBOT'S TOWER

Kilkenny

## Final Report on Conservation Works

2011

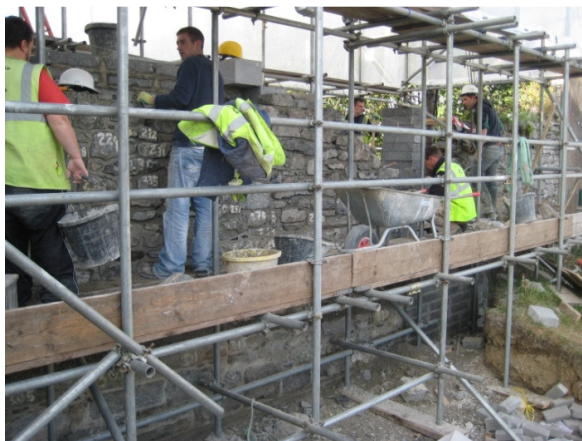
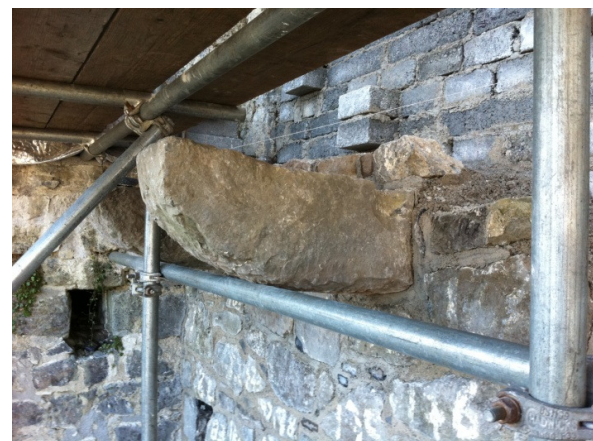
Covered scaffolding allowed for working in inclement weather and protecting the work on completion. Below two corbel stones were reinstated.

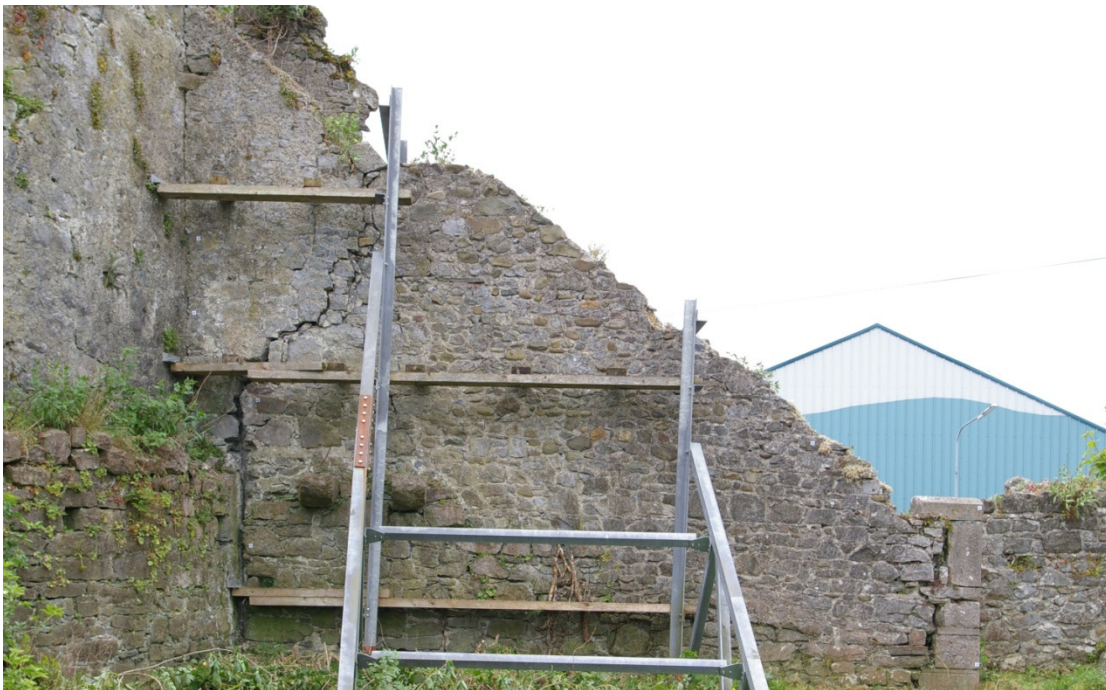
A close up of the east elevation, with corbel stones, which once may have supported a timber wall walk. The numbered stones have been rebuilt in the correct location. Compare it to the rectified photograph below dating to before the wall was taken down in 2007.
